Vatershed Vatch

Newsletter of the Jordan River Watershed Council

Fall 2010, Volume 7

Stimulus Funded River Restoration!

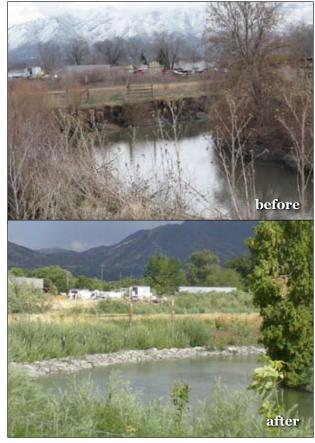
Vertically eroding banks are clearly visible in the "before" picture at one of seven Jordan River sites to receive stimulus funds for restoration. Bank stabilization included regrading the banks, placing a rock layer to protect the base (toe) of the slope, and revegetating with native plants.

Bank stabilization is needed where banks have become too steep, eroding vertically in many cases (see "before" picture at right). Extremely steep slopes cannot support the vegetation that helps stabilize and secure the soil. Construction equipment is used to reshape the bank, rock is added at the base of the slope (called "toe protection"), and the bank is then planted with native vegetation. A biodegradable coir fabric is placed on the slope to help with stabilization until the plants can become established. In some places *emergent benches* were included in the design. An emergent bench is graded to an elevation within 12" above seasonal low water levels. This creates a flat, low lying area closest to the water's edge *continued on page 2*

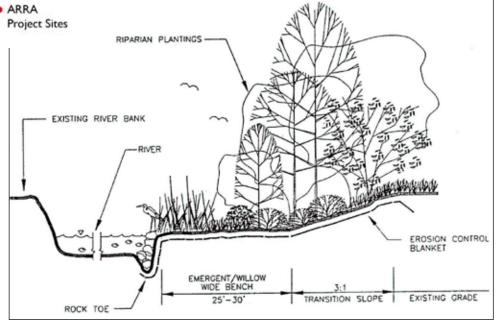
"Emergent Bench" design used in many of Salt Lake County's bank stabilization projects

water-loving plants and also provides flood water storage (see illustration).
